A Controversial Restoration

Renato and Franco Zamberlan discuss recent work on St Mark's Clock in Venice.

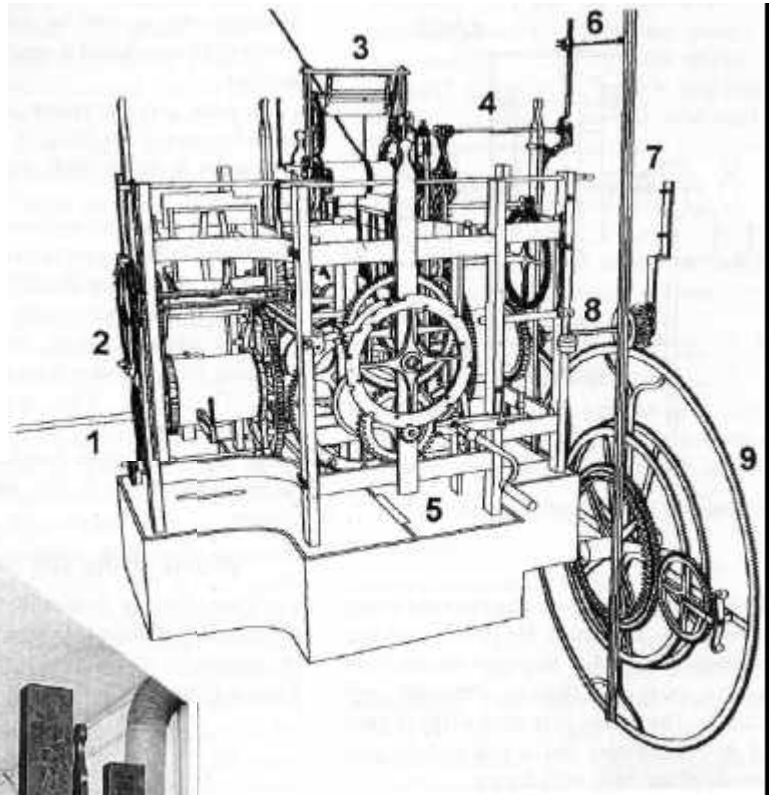
1. Above: The movement prior to the recent restoration, as it appears from a drawing made by Piaget. 1, the subsidiary dial arbor, connected with the time train on the opposite side of the movement; 2, the 132-blow strike train; 3, the 5 minutes mechanism, added in 1858, to move the panelled wheels for digital time indication; 4, The time train; 5, The second Moor train (the first Moor train is not visible, opposite to this); 6, The link from the escapement to the long wooden pendulum rod; 7, The octagonal wooden pendulum rod, 13,6 ft long; 8, The transmission arbor for main dial indications; 9, Astronomical mechanism for the main dial.

The main parts of the clock are visible on the drawing, 1. Not visible here is the Magi's carousel mechanism on the upper floor of the Tower.

To accommodate the new long arbor required lifting the 5-minute mechanism, (3, on drawing, 1). A steel structure was made for this purpose and we must say that it doesn't follow any antique style at all. It makes use of modern square tubing anyone can find at a local metal

The new point where the suspension is attached is exactly in the middle of the clock. Prior to the recent restoration it was placed to one side. The rod was connected to the escapement by a horizontal link (6, in drawing 1) as is common on Comtoise clocks. This avoids interference with the transmission arbor (8, in drawing 1), which carries the motion to the dial and protrudes from the middle of the movement.

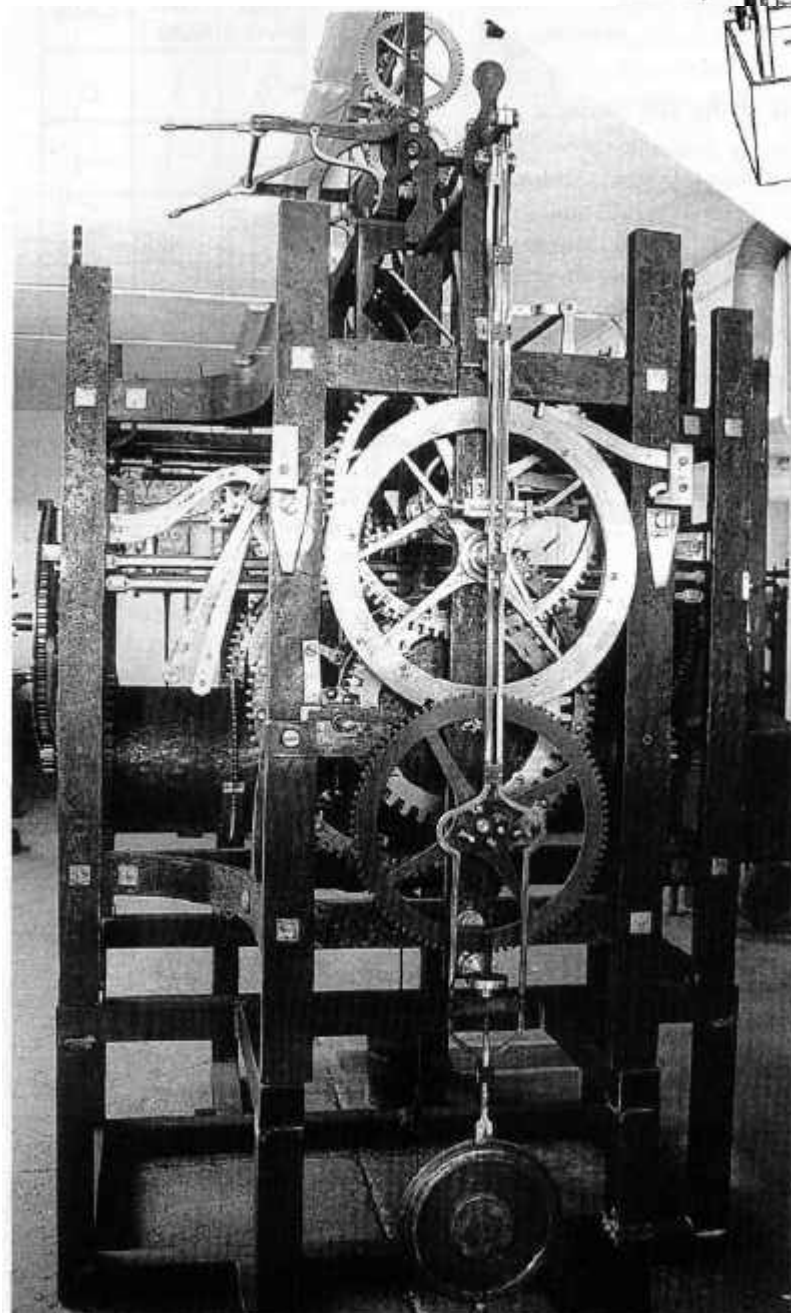
2. Left: The clock after the recent restoration.

Here is how Brusa and Gorla carried out the restoration, 2. They cleaned and polished all the parts, installed new bushings, burnished pivots, replaced fly-springs, etc... but many other interventions were also made.

Gorla placed the new pendulum on the other side of the mechanism but here too the secondary dial arbor protrudes from the middle. He solved this problem by fabricating a sort of 'open-frame' rod, through which the arbor can pass, 2 and 5.

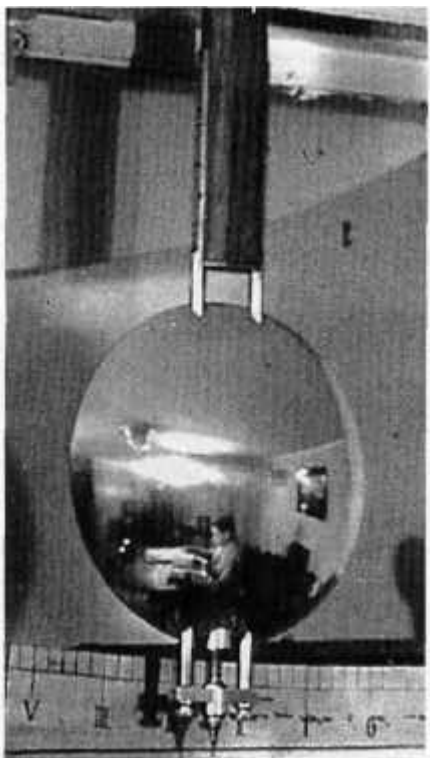
3. The 1858 bob, signed by Luigi De Lucia, mirrors the scene in the room below the clock.

They replaced the 2second pendulum (1800 bph) made in 1858 (13.05ft. long, with an octagonal wooden rod and a polished lenticular brass bob engraved; "Luigi De Lucia", 3, with a new one, 2600 bph (6.2ft. long iron rod; cast iron bob punched: "Alberto Gorla 1998", 4). We think this is wrong not only from the conservation point of view, but also from the historical point of view.

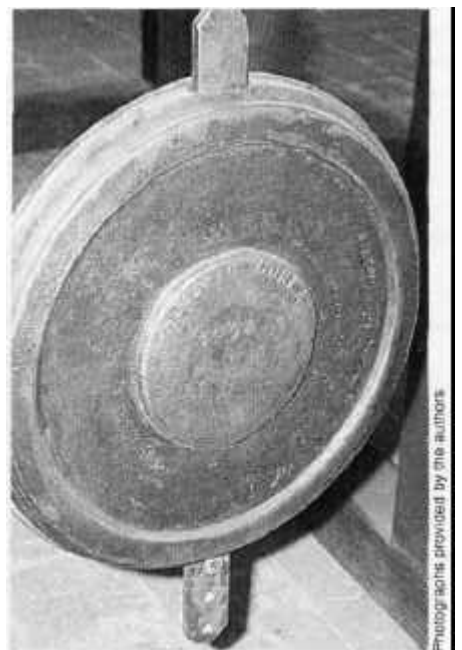
4. The new bob. Not very elegant, in our opinion.

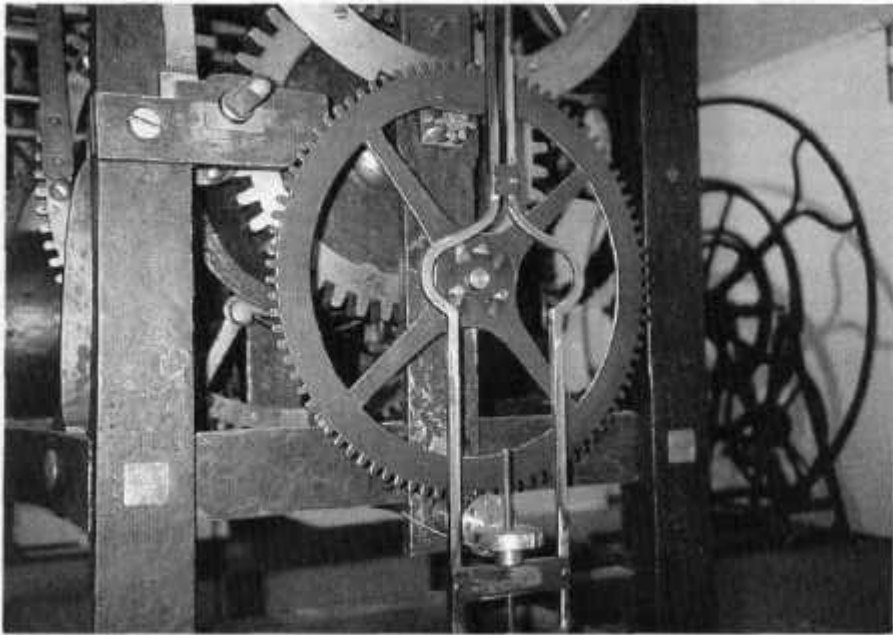
5. In this photo the secondary dial arbor is not present, but it will be fixed to the three metric pitch steel screws seen on the black finish wheel hub. Note the roughly plugged holes.

Using stainless steel cap head machine screws or hexagon galvanised metric nuts and bolts on a 18th Century movement, is simply wrong. We could also see a newly made wheel whose fixing holes were drilled out of place on the hub. John Wilding says it is not necessary to discard a wheel if the misplaced holes are plugged and plain finished to hide them, prior to making new ones. Gorla plugged the holes but he roughly ground the surplus metal away, with no regard to the black matte finish. The result is that the misplaced holes are still very visible on the dark surrounding, 5.

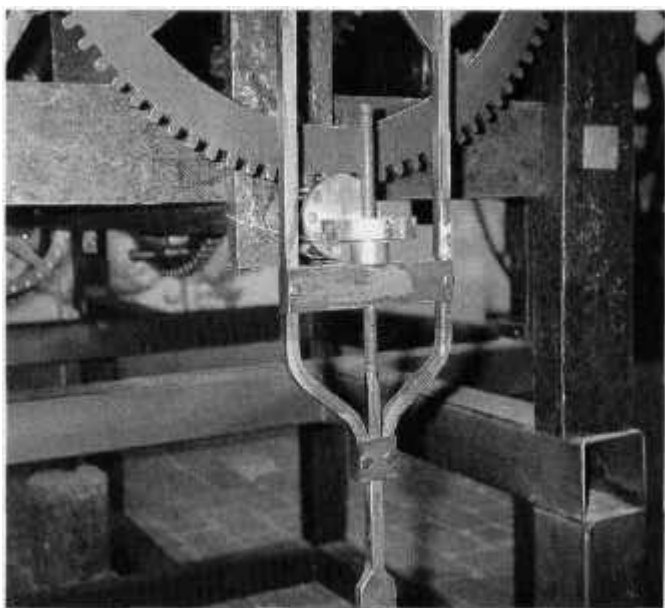
7. Detail of the time regulating screw on the new pendulum.

Is it possible that a 1757 pendulum had metric regulating screws or square cold rolled steel for its structure, as found in Gorla's reproduction, 7 and 8?

On the pendulum itself, there are micrometric adjustment screws both for the time and for the beat, made with pieces of metric threaded rod, 7 and 8. Were these used in the 18th Century pendulum Brusa and Gorla wanted to reproduce?

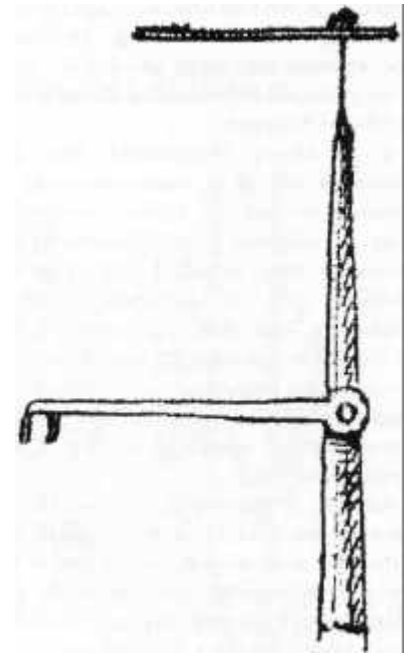
6. The sketch by A. Marini and G. Doria showing the horizontal link to the pendulum predating the 1858 movement.

A drawing taken from a technical brief by Annibale Marini (clock technician) and Giovanni Doria (*temperatore*) written for the Venetian Municipality on 22nd July 1856, before De Lucia's work, indicates that this is an illogical construction. This "*Relazione*" describes the clock and the works required for its repair. A sketch, 6, shows the horizontal link to the pendulum, and the text says that "improvements to this part are needed, to enable the *temperatore* dismantling and cleaning it, being the actual part fixed". Brusa says this must be simply a proposal, because in the drawing the arm is facing left instead of right. We cannot however be sure of the viewpoint of the artist.

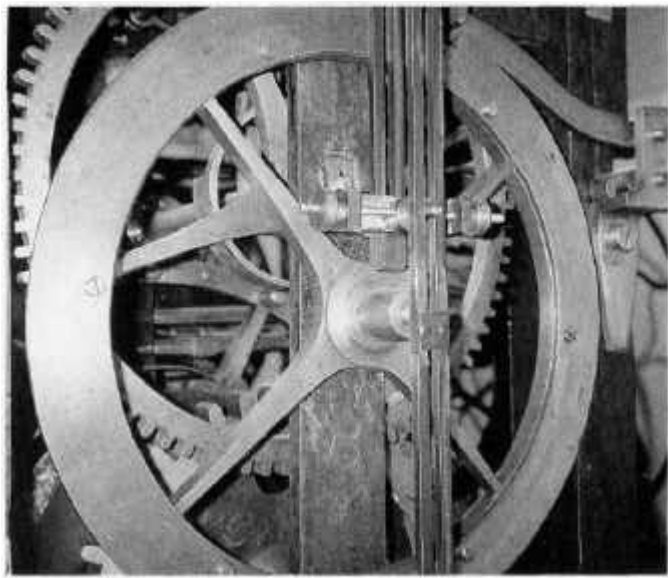
8. Detail of the beat regulation device on the new pendulum.

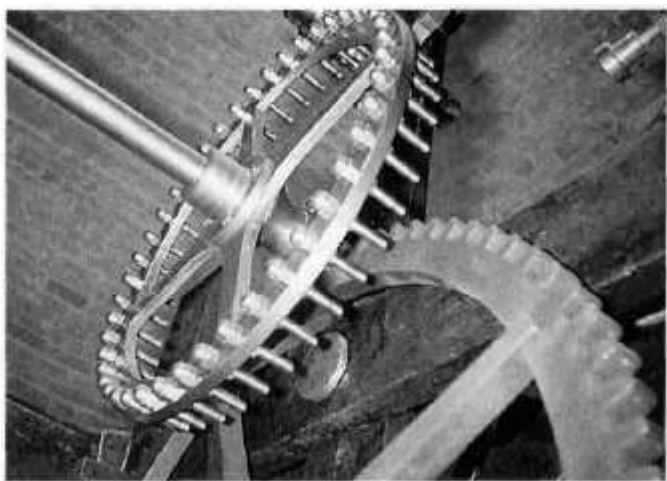
The modified beat rate of the new pendulum required the rebuilding of the escapement; the restorers replaced the existing anchor and pin-wheel with new ones. They retained the pinwheel, although they claimed to be returning the movement to the 1757 state. At that time, however, the escapement was a Graham dead-beat. Furthermore, they used stainless steel machine cap-head screws to form the pins, 10.

10. The new escape wheel, the pins turned from cap-head screws.

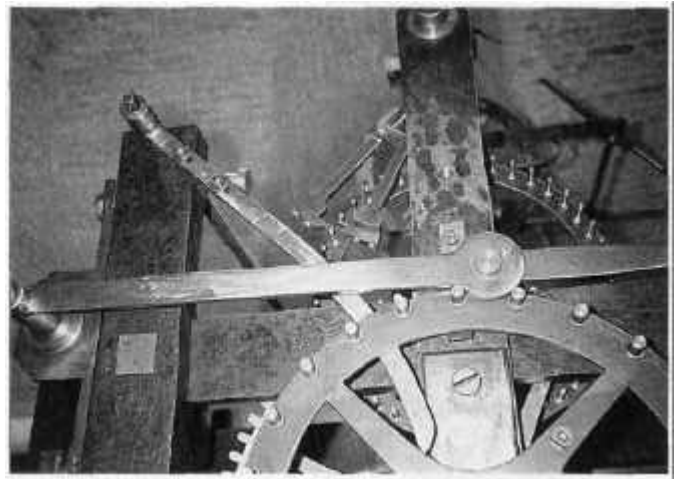
9. The new wheel and levers made to actuate the 132-blow strike. Two pins on the spokes trip the diagonal lever to actuate the strike at noon and midnight. Note the unfinished grinding signs.

All over the clock, there are several signs of grinding, left unpolished, 9. The level of the finish is more typical of large mechanical industrial clocks than antique clocks.

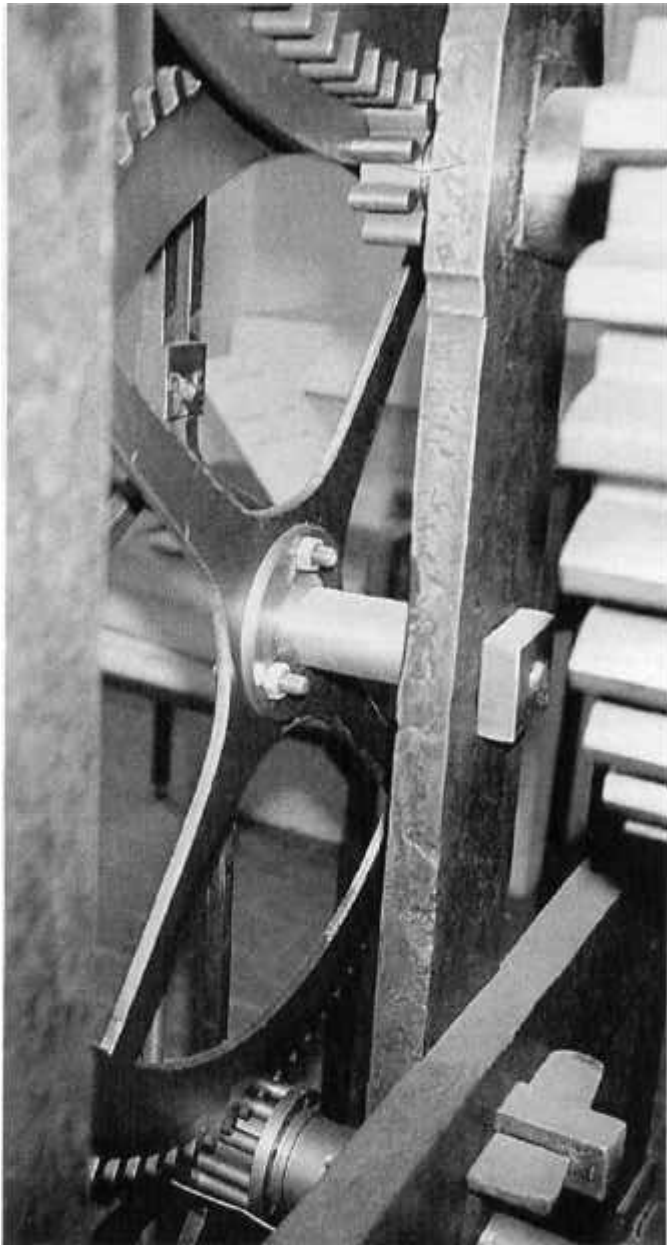
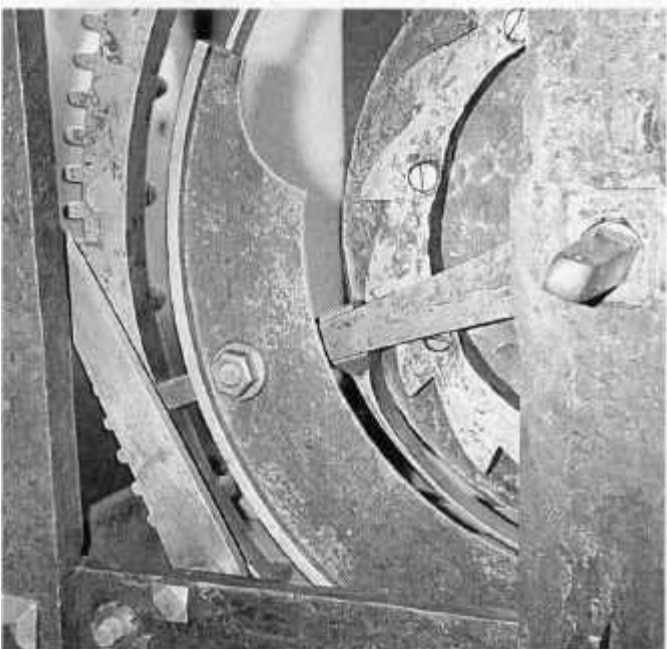
Hexagon nuts and bolts of the quality found in hardware stores have been widely used (see 11 for other examples). Was it too difficult or expensive to make them on a small lathe with the same proportions and materials used for the originals? Galvanized screws are simply ugly on a clock, not to speak of an 18th Century mechanism. We saw only a couple of screws that appeared to be made expressly for this clock: they were easily distinguishable from the old ones because the slots were not as neat as they should have been. They were clearly cut with a hacksaw, not with a cutter on the lathe.

11. Example of the use of hexagon bolts.

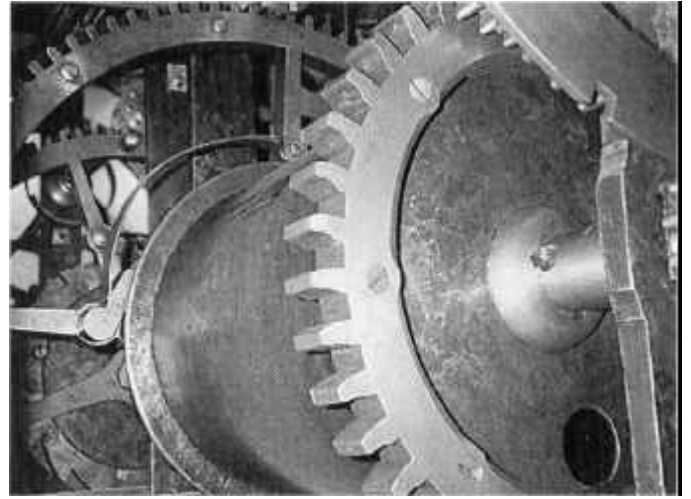
12. Unrestored winding wheel.

It is worth noting that on the website there is a picture of a very worn wheel, shown to represent the bad condition of the clock prior to the restoration. This wheel (and another three like it) has not been restored. These are winding wheels that won't be used with the electrified system devised by Gorla to wind the clock, **12**.
